Manhole Inspection Summary

Manhole # S31I2020MH

Insp Date: **1/9/07 10:50 AM**

Location Address: **6302 MOSSWAY**

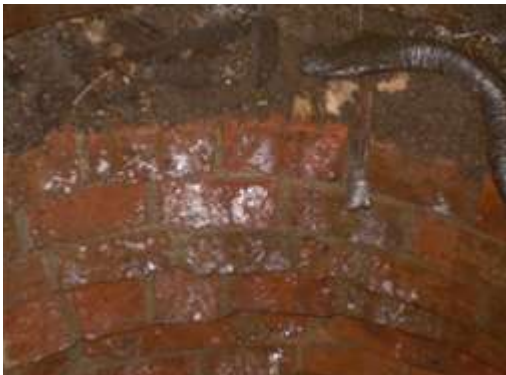
Defect

Chimney / Frame Adjustment ☒ Exists Material: **Brick** ☐ Parged Height: **12** (in.)
Condition: ☐ Sound ☐ Cracked ☒ **Root Intrusion** ☐ Loose Brick ☐ Deteriorated
Infiltration: ☐ None ☒ **Joint** ☐ Cracks ☐ Mortar ☒ **Roots** ☐ Wall

Adjustment infiltration.

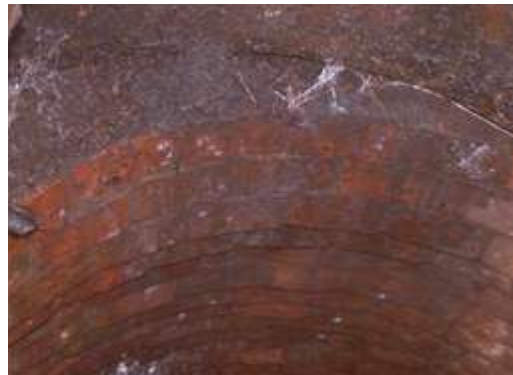
Defect

Frame Offset: **4** (in.) Condition: ☐ Sound ☐ Cracked ☒ **Leaks**

Frame leaks. Frame offset. Adjustment root intrusion and infiltration.

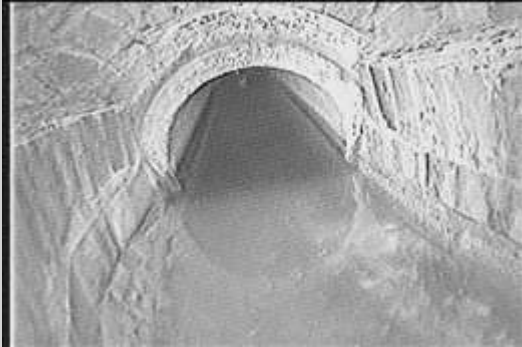
12 in. Circular Gravity Sewer Pipe Out @ 12 O'Clock

Invert Depth: **12.02** (ft.) Flow Characteristics: **Slow**

Deposits: ☒ None ☐ **Mud** ☐ Sludge ☐ **Debris** ☐ Grease

Infiltration: **None** Pipe Seal Cond: **Unknown**

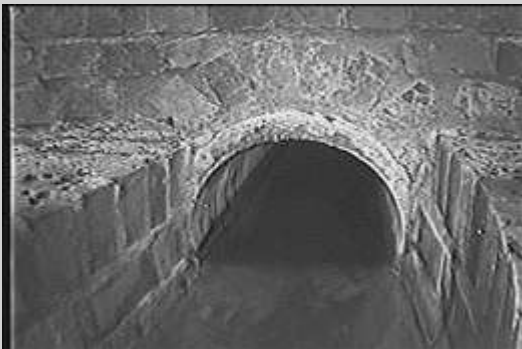
12 in. Circular Gravity Sewer Pipe In @ 4 O'Clock

Invert Depth: **11.95** (ft.) Flow Characteristics: **Slow**

Deposits: ☐ None ☒ **Mud** ☐ Sludge ☒ **Debris** ☐ Grease

Silt Depth: **2** (in.) Deposits Extent: **Light**
